# ENGINEERING CONDITION SURVEY AND STRUCTURAL INVESTIGATION OF MONTGOMERY LOCKS AND DAM OHIO RIVER

March 1977

Final Report

Prepared for U. S. Army Engineer District, Pittsburgh  
Pittsburgh, Pa. 15222

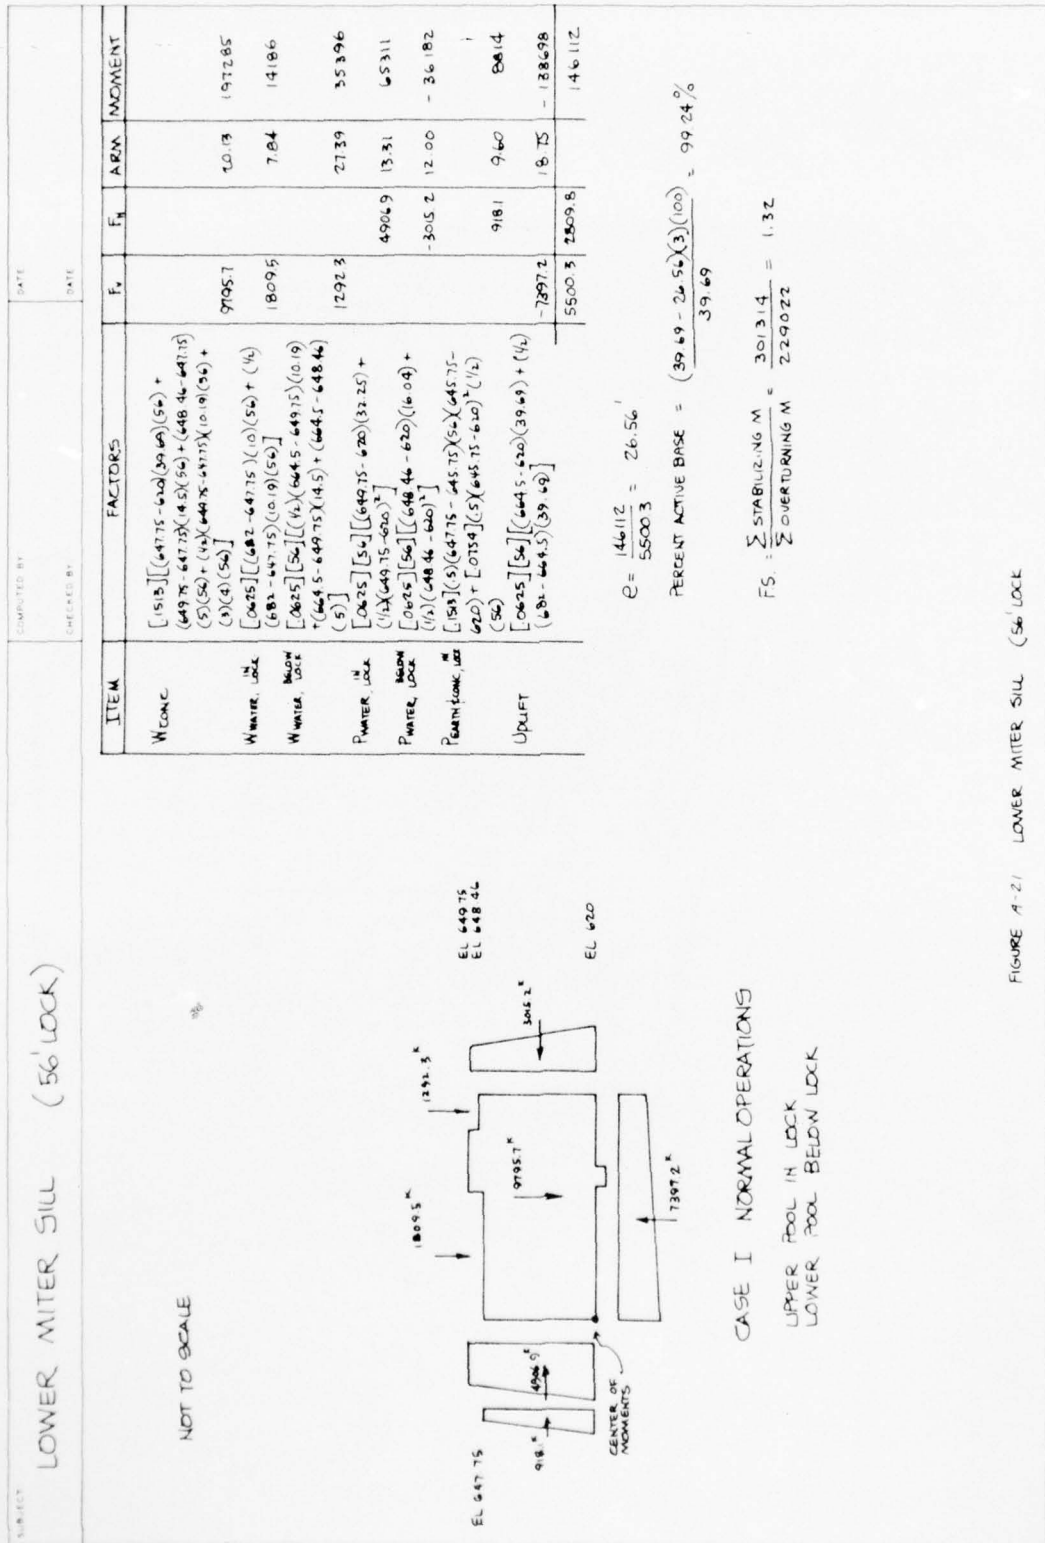
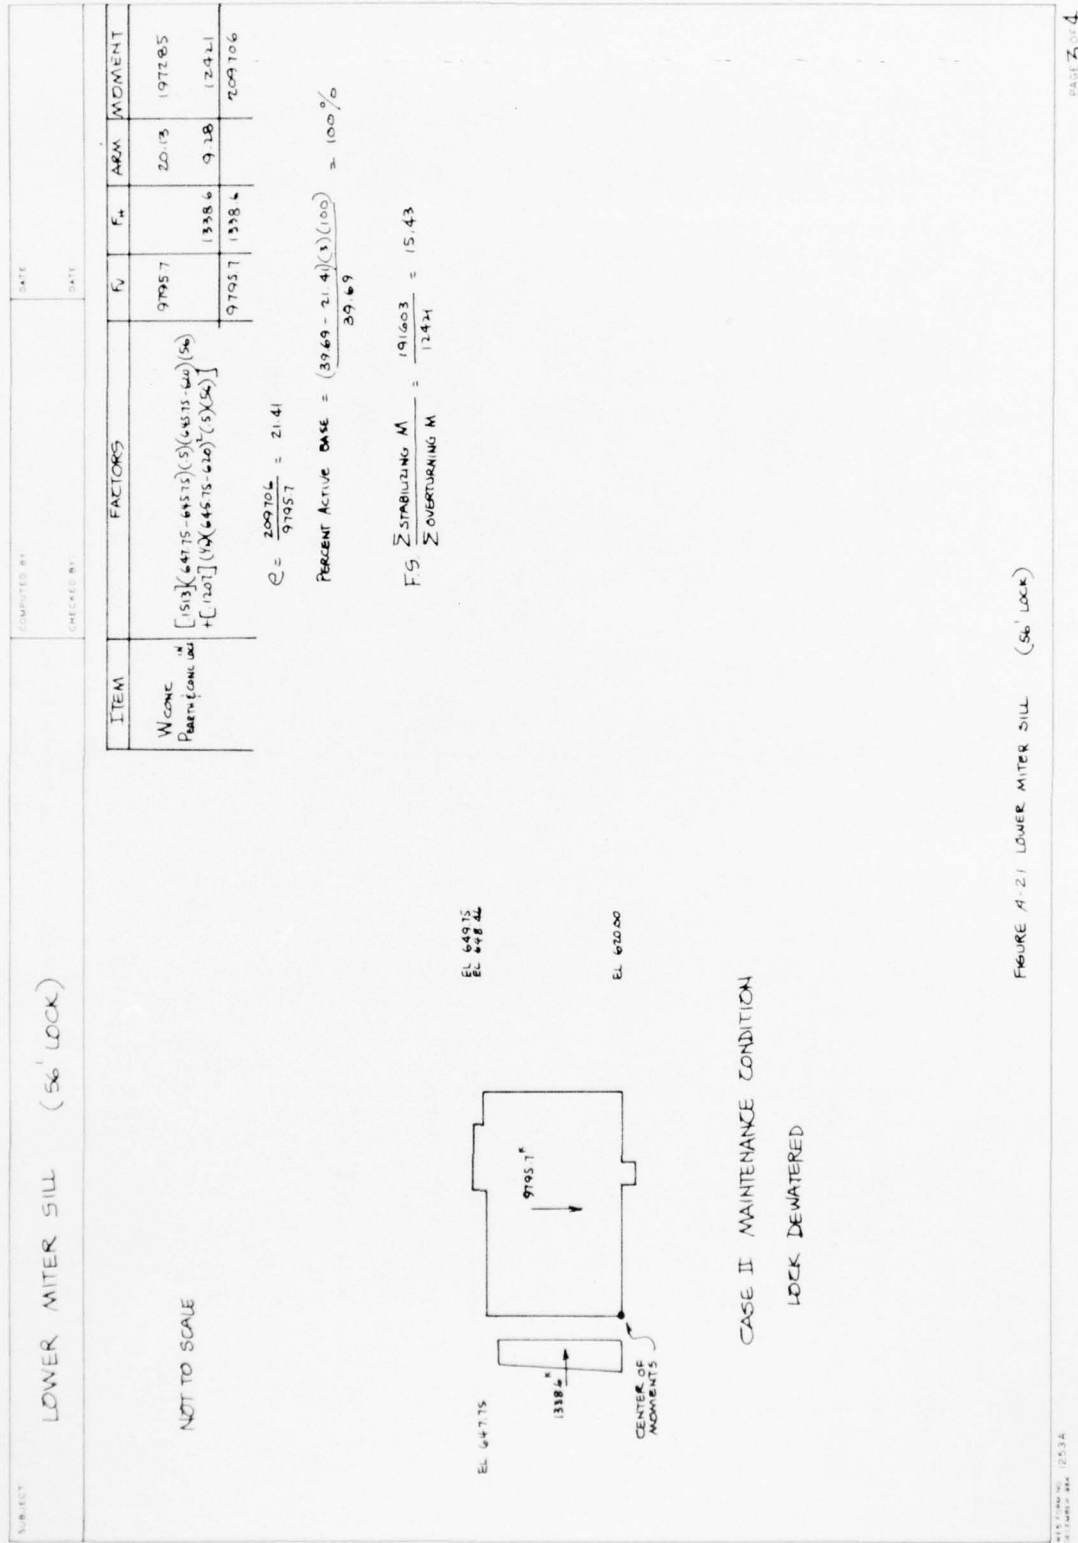
FIGURE A-21 LOWER MITER SILL (56' LOCK)

5.16 The miter sills are inadequate for sliding if the locks are dewatered.

SUBJECT	COMPUTED BY CHECKED BY	DATE	DATE
LOWER MITER SILL (56' LOCK)			
SLIDING	<p>CASE I NORMAL OPERATIONS</p> $R = \sum FV \tan \phi + \text{KEY RESISTANCE}$ $= (5500.3)(.5658) + (4)(56)(.075)(144)$ $= 3112.1 + 2419.2$ $= 5531.3$ $SSF = 5531.3 / 2809.8$ $= 1.97$	<p>CASE I NORMAL OPERATIONS</p> $f = \left(\frac{2}{3}\right)\left(\frac{P}{Q}\right) / L$ $= \frac{(2)(5500.3)}{(10)(13.13)} / 56$ $= 4.98 \text{ KSF}$	
	<p>CASE II MAINTENANCE CONDITION</p> $R = (9795.7)(.5658) + 2419.2$ $= 5542.4 + 2419.2$ $= 7961.6$ $SSF = 7961.6 / 1338.6$ $= 5.95$	<p>CASE II MAINTENANCE CONDITION</p> $F = \frac{P}{A} + \frac{M_c}{I}$ $= \frac{9795.7}{(39.69)(56)} + \frac{(9795.7)\left(\frac{49.69}{2} - 21.4\right)(1984)(.2)}{(56)(39.69)^3}$ $= 4.41 + 1.04$ $= 5.45 \text{ KSF}$
